# Implementation of Safety Risk Management in Aircraft Airffame Maintenance

### Untung Lestari Nur Wibowo<sup>1</sup>, Iwan Engkus Kurniawan<sup>2</sup>, Hadi Prayitno<sup>3</sup> <sup>13</sup>Akademi Penerbang Indonesia Banyuwangi, Indonesia <sup>2</sup>Politeknik Penerbangan Indonesia Curug, Indonesia

Received: May 2, 2023Accepted: August 16, 2023Published: August 31, 2023Citation: Wibowo, U, L, N., Kurniawan, I, E., Prayitno, H. (2023). Implementation of Safety Risk Management in Aircraft Airffame Maintenance. Sinergi International Journal of Logistics, 1(1), 85-95.	<b>ABSTRACT:</b> This study analyzes the application of Safety Risk Management in the practice of aircraft maintenance at AMTO (Aircraft Maintenance Training Organization) Indonesia Aviation Polytechnic Curug. The research method used is descriptive qualitative. Starting with hazard identification, risk assessment, and continuing with mitigation actions. Risk assessment uses the Risk Matrix. The results showed that 9 hazards were at tolerable levels, namely 4 hazards in the component release phase, 3 hazards in the inspection phase, and 2 hazards in the installation and adjustment phase. Recommended mitigation meas

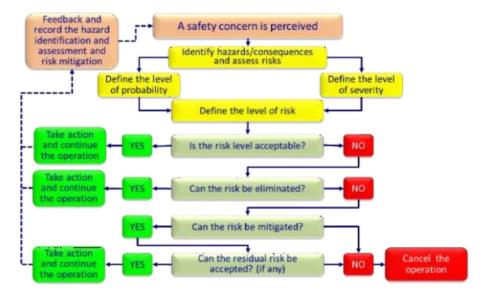
### Figure 1. HIRAM FLOW

This study uses a descriptive qualitative method, namely the process of hazard identification, risk assessment, and mitigation. This series of processes is also one of the proactive methods in the safety management system in accordance with ICAO Annex 19, namely actively identifying safety risks through a series of analyses of activities within an organization. In the process, the flow of risk assessment and control is shown in Figure 1 of the HIRAM (Hazard Identification, Risk Assessment and Mitigation) flow.

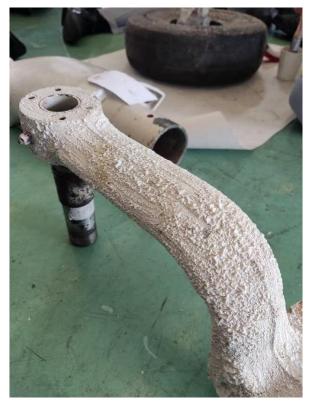
Figure 3. Use of Paint Remover

prevention. Using paint remover is dangerous if it gets in your hands or eyes because the material is hot and can burn your skin. An example of using paint remover is shown in Figure 3. The existing mitigation is to use PPE, namely gloves and goggles, but it can still penetrate the inner skin. The probability assessment is 4 and the severity is D. The suggested mitigation is by adding safety promotion and related training such as through public lectures or sharing sessions.

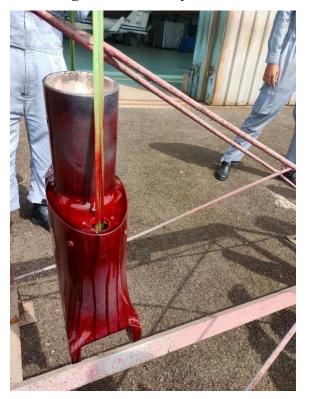
Figure 4. Use of Dye Penetrant

The use of NDT Dye Penetrant is carried out to detect cracks in certain components. hazard

that arises has the potential to cause injury or irritation to the skin. In addition, the remaining penetrant can leave marks on the inspected part if it is not cleaned properly and thoroughly. The rest of the color can appear again even though it has been repainted with the color of the plane. The probability rating is 4 and the severity is D. Use Dye penetrant as shown in Figure 4.

The existing mitigation is by using PPE. The suggested mitigation is by adding safety promotion and training. and additional time for drying remaining penetrant and cleaning which must be maximized and monitored.
